Effect of Sediment Characteristics on Erosion and Deposition in Ephemeral-Stream Channels

GEOLOGICAL SURVEY PROFESSIONAL PAPER 352-C

By S. A. SCHUMM

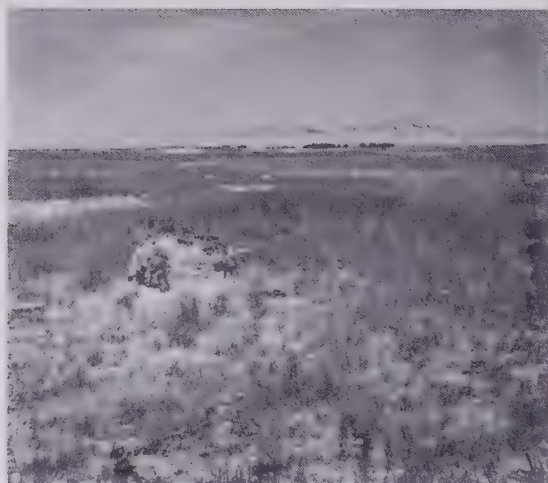
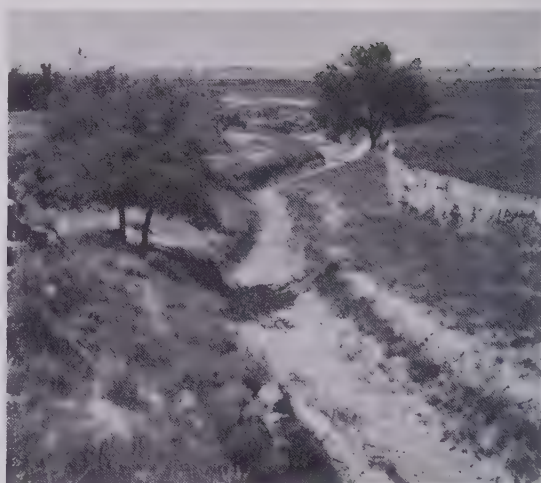
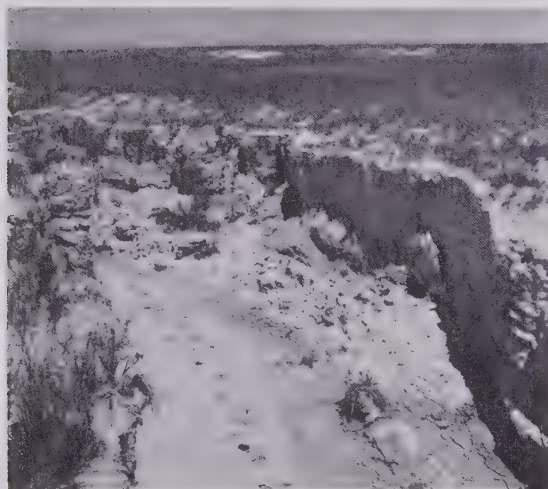
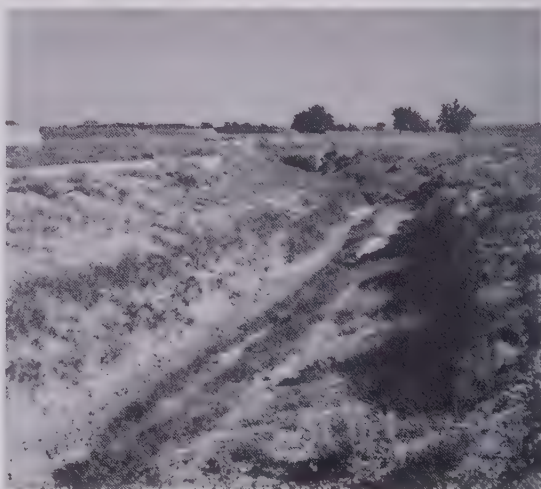
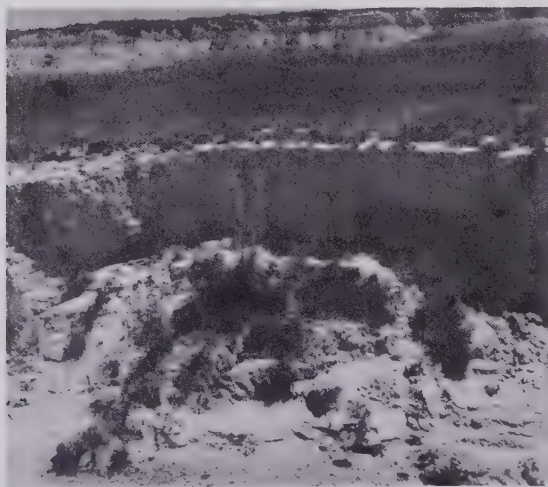
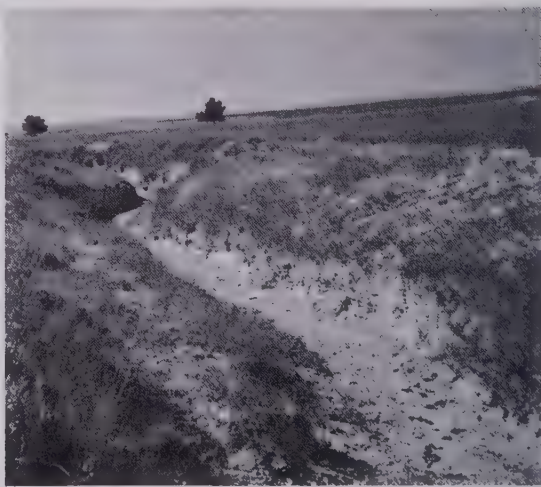
FIGURE 20.—Sage Creek, S. Dak., above section 8.

- D, Station 1, view upstream. The inner terrace formed by lateral deposition along both banks is best displayed in this reach, between sections 4 and 5.

- E, View upstream from station 2 a short distance downstream from section 6. Lateral deposition of fine sediment has almost covered banks of gully.
- F, Cross section 7, view downstream. Banks are completely covered by recent deposits. The small raw channel at the bottom of the gully may be the result of renewed degradation.

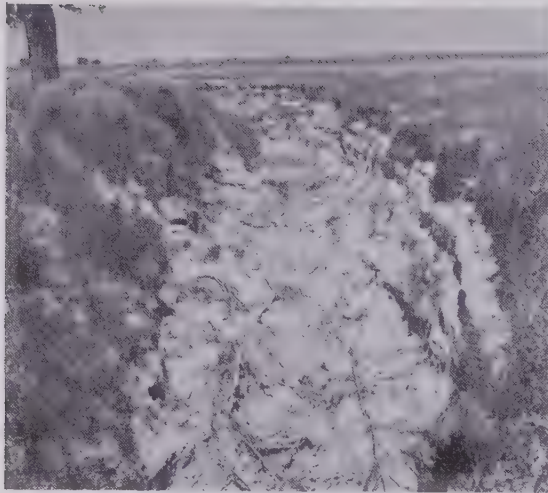
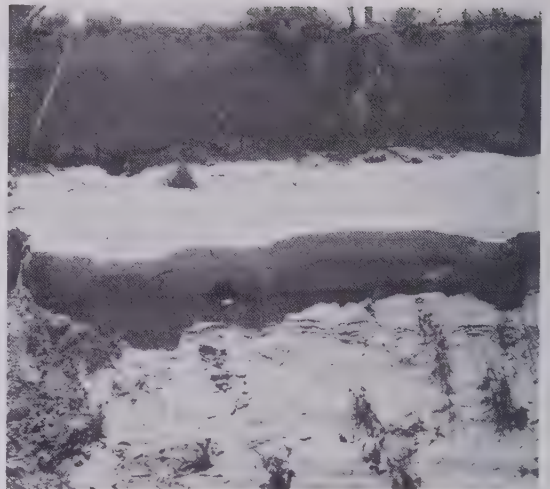
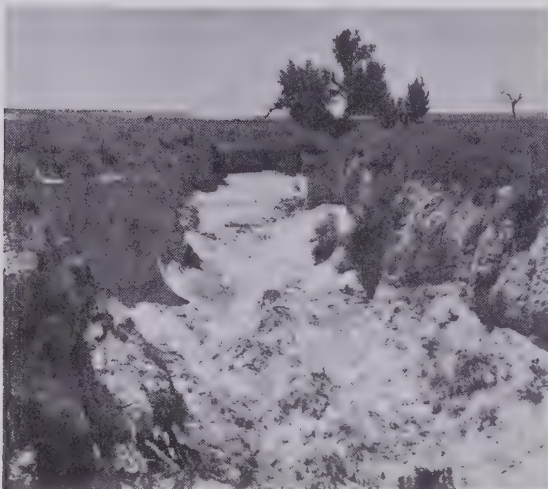
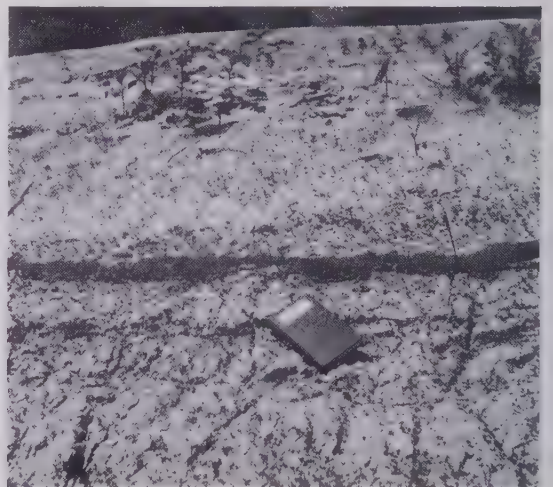
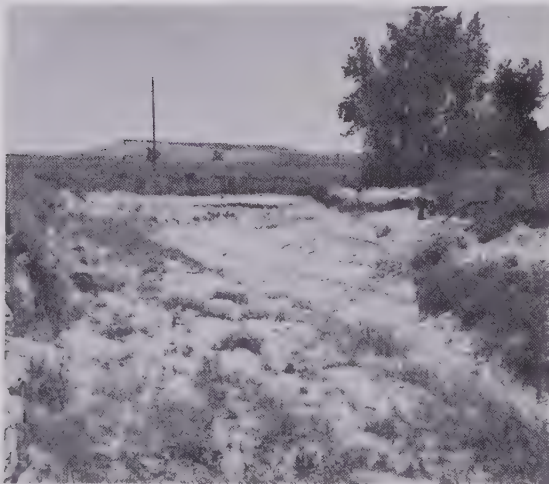
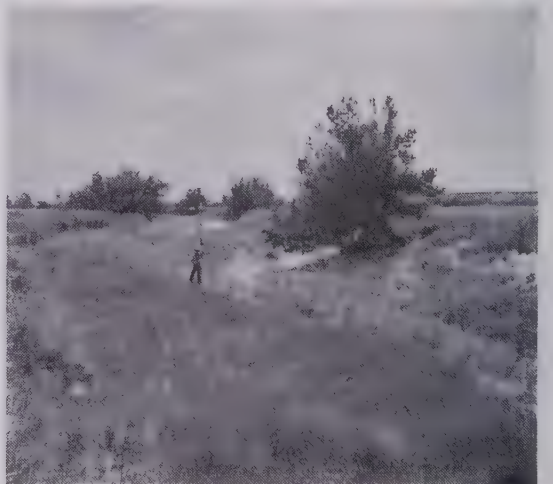
FIGURE 21.—Sage Creek, S. Dak., below section 8.

- A, View downstream from station 3. Recent trenching has exposed cottonwood tree roots on floor of channel. View typical of conditions at section 9 except for exposed roots.

- F, Cross section 13, view downstream. A more advanced stage of aggradation and vegetative growth is shown at this section about 3.3 miles downstream from cross section 10.

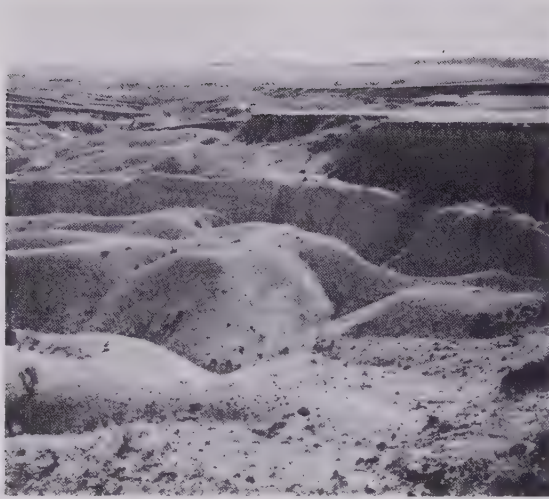
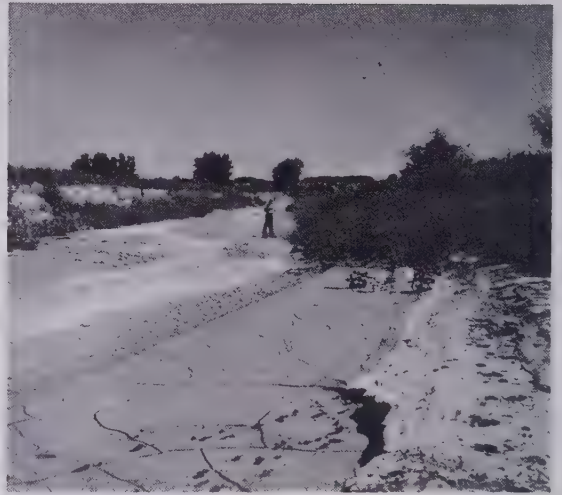
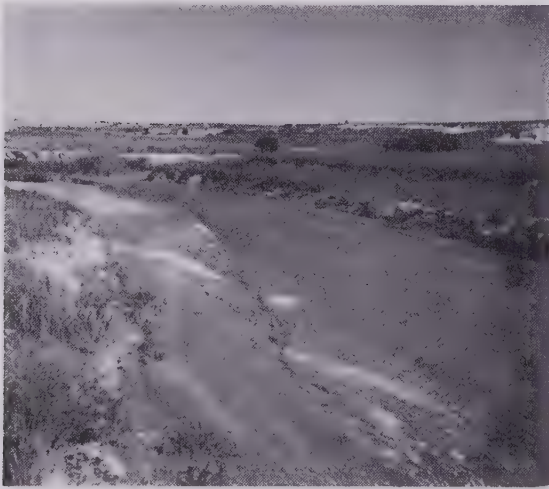
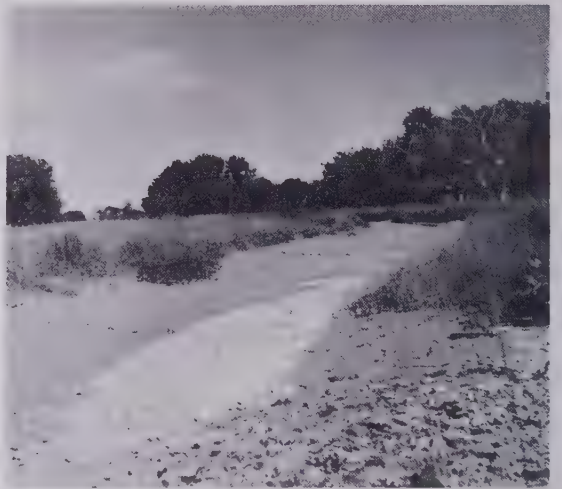
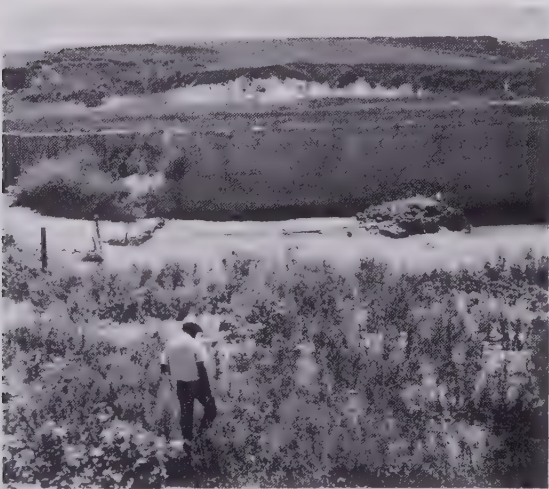
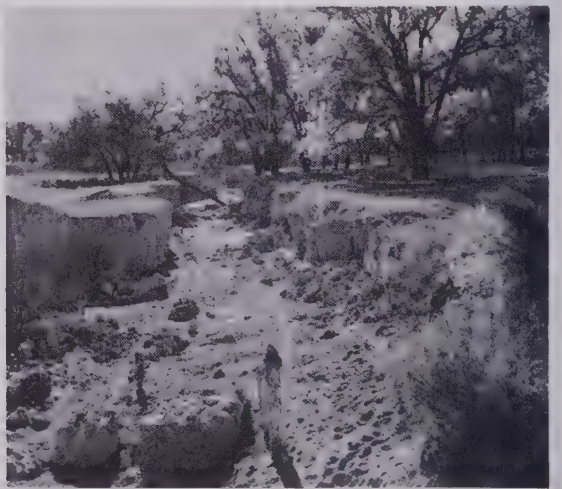
FIGURE 25.—Sand Creek, Nebr.

- A, Badlands in headwaters of Sand Creek. Removal of the protective sod cover allows development of badlands in soft rocks of the White River group.
- B, Cross section 3, view downstream. Relatively wide sandy channel typical of Sand Creek above aggrading reaches.
- C, Cross section 6. Note recent slump block at base of bank. Fence to left shows signs of recent partial burial.
- D, Cross section 7, view downstream. Note development of berms along sides of channel. Vegetative growth is promoted by deposition of fine sediments.
- E, Cross section 8, view downstream. Channel is almost completely filled by recent deposition. Vegetation is encroaching on the parts of the channel that are bare.
- F, Recently formed gully at county road between cross sections 10 and 11.

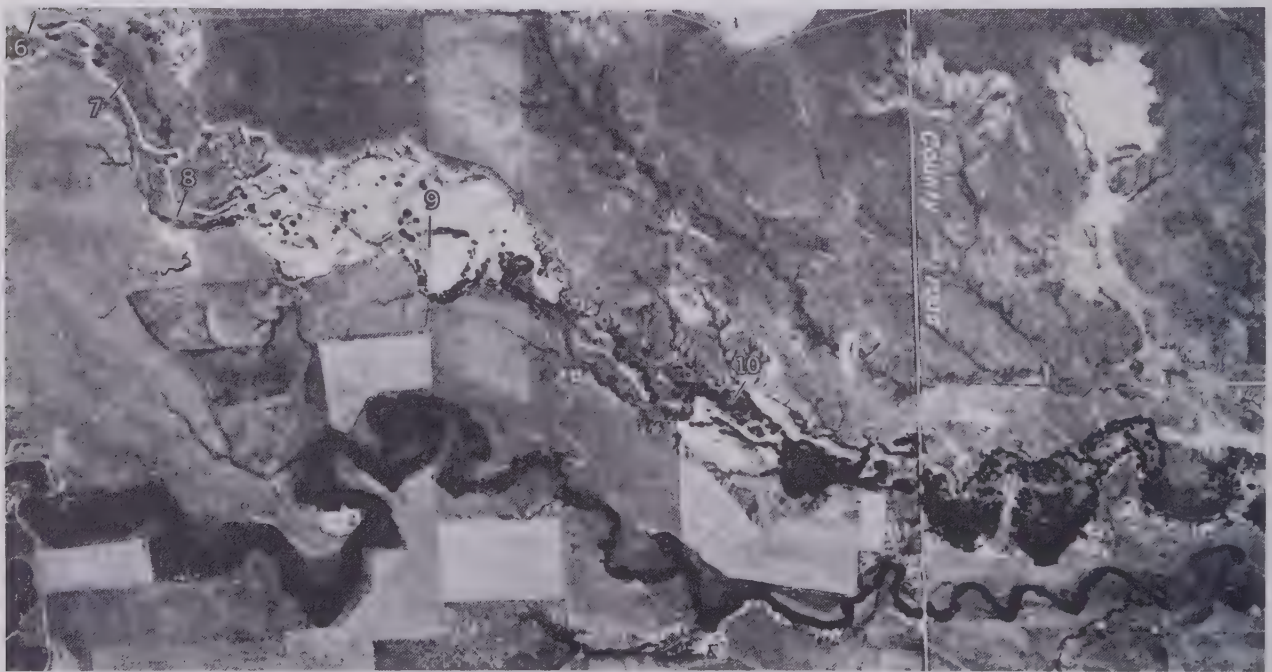
FIGURE 26.—Aerial photographs of part of the Sand Creek drainage basin, Nebr. *A*, taken in 1939; *B*, taken in 1954. Light-colored area at upper left of both photographs is area of maximum deposition. Locations of cross sections 6 to 10 are given on photograph *B*.

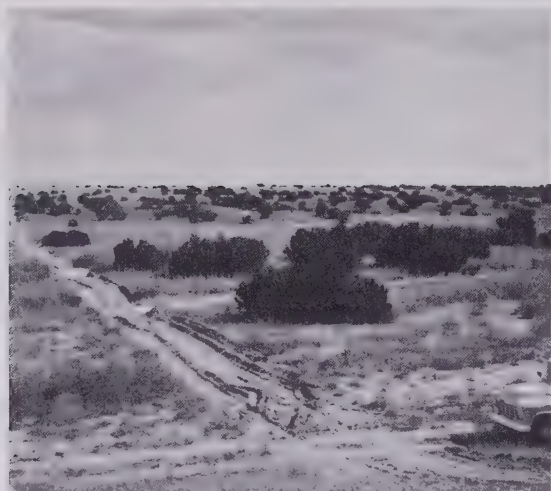
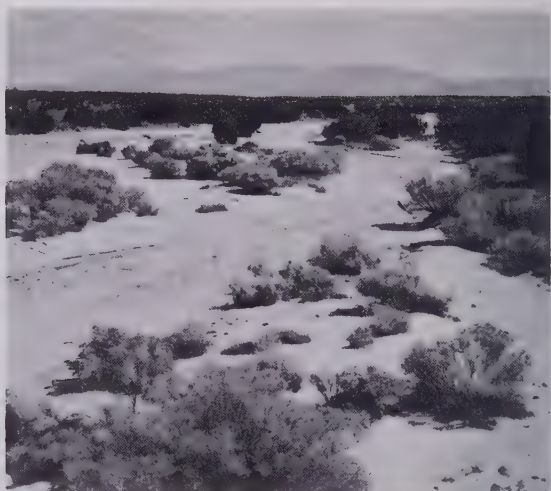
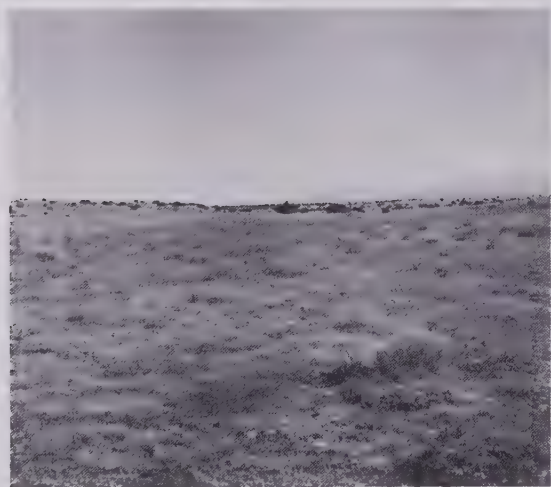
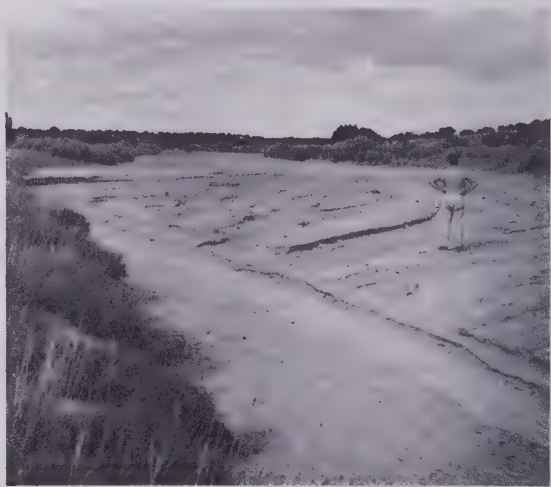
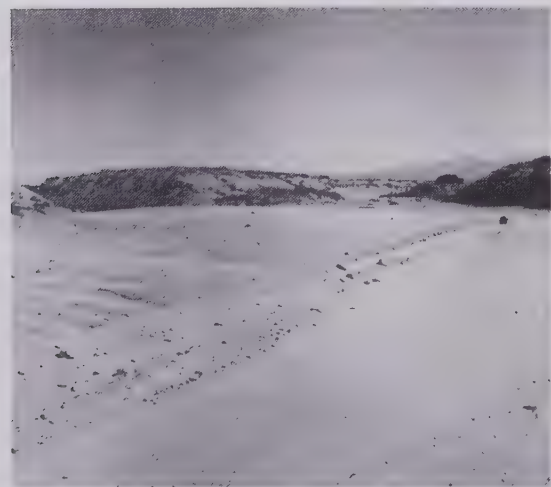
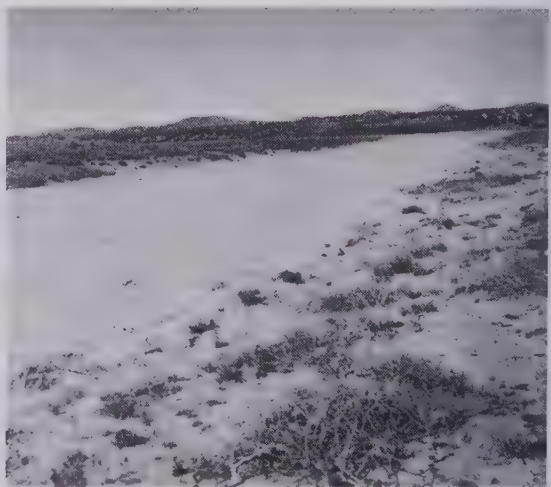
FIGURE 30.—Arroyo Calabasas, N. Mex.

- D, Channel of Arroyo de los Frijoles near cross section B. Several channels appear to be degrading between sagebrush and juniper trees, thereby forming a braided channel.

- E, Irregular channel surface suggests incipient degradation in Arroyo de los Frijoles downstream from cross section C.
- F, Near cross section 8, view downstream. Channel is being progressively filled. Compare with photograph of section 6 (fig. 30 C).

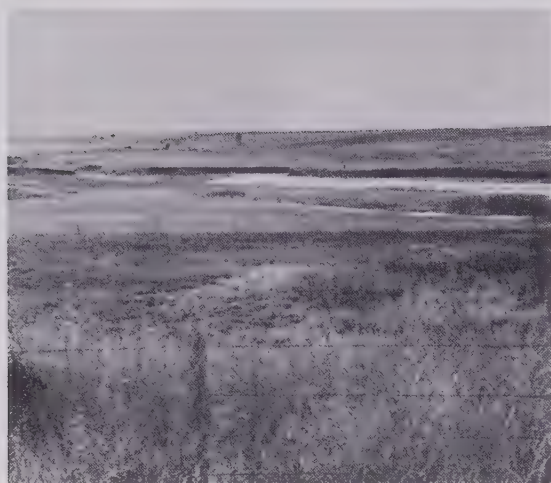
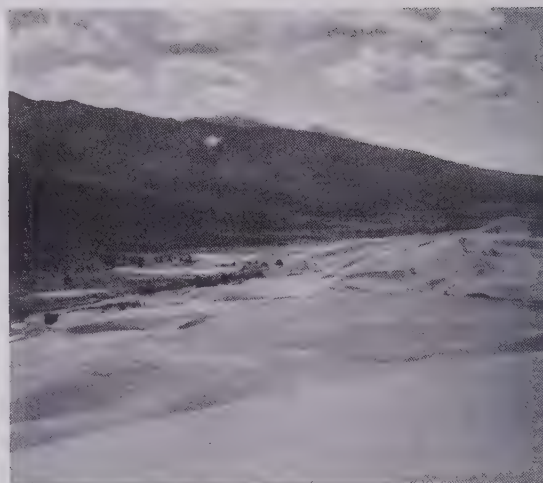
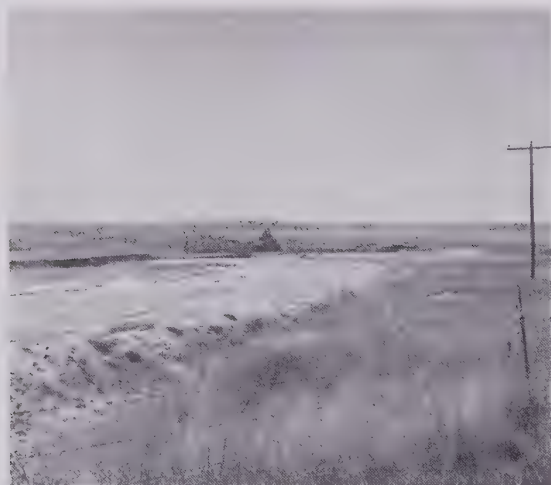
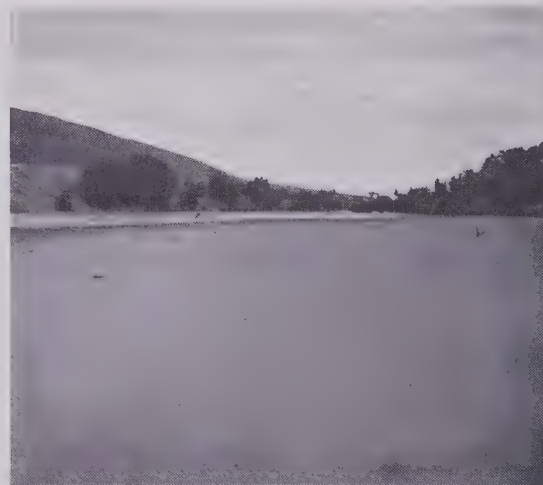
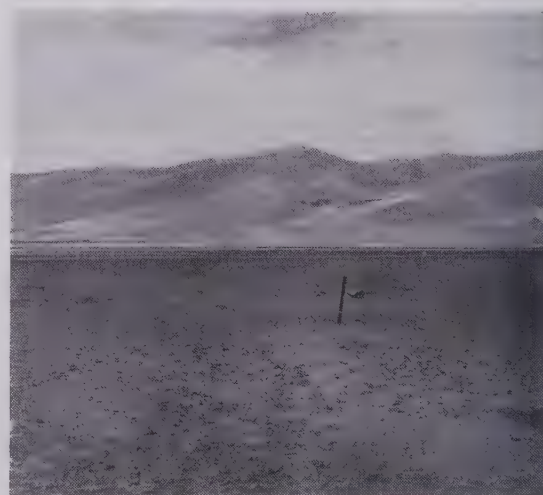
FIGURE 34.—Bayou Gulch and Medano Creek, Colo.
